2: Septic and Waste

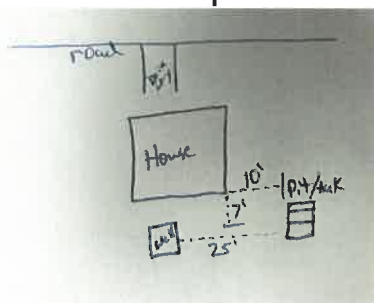
Site Sketch / Map

The disposal works is located 25 feet from the well.

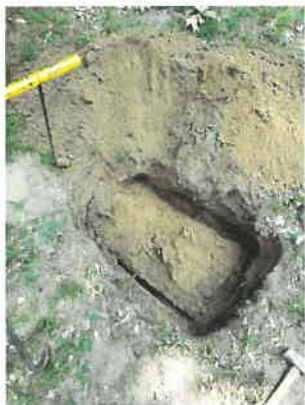
Slab top

Homemade/block

The capacity of the tank is 400 gallons.

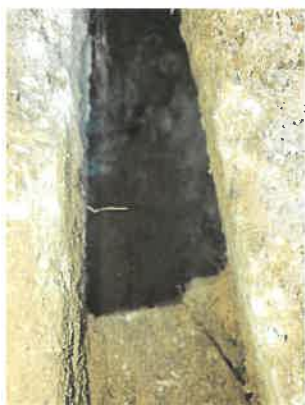
Pumped

There was nothing to pump all the sewage drained through the bottom.

This system is a pit with no bottom and has no treatment or sewage separation prior to soil absorption. Recommend having a permitted septic system installed.
